TURBIDITY MONITORING AT SELECT MDOT CONSTRUCTION SITES

STATE STUDY 225

JUNE 2012

**Prepared for:
Mississippi Department of Transportation**

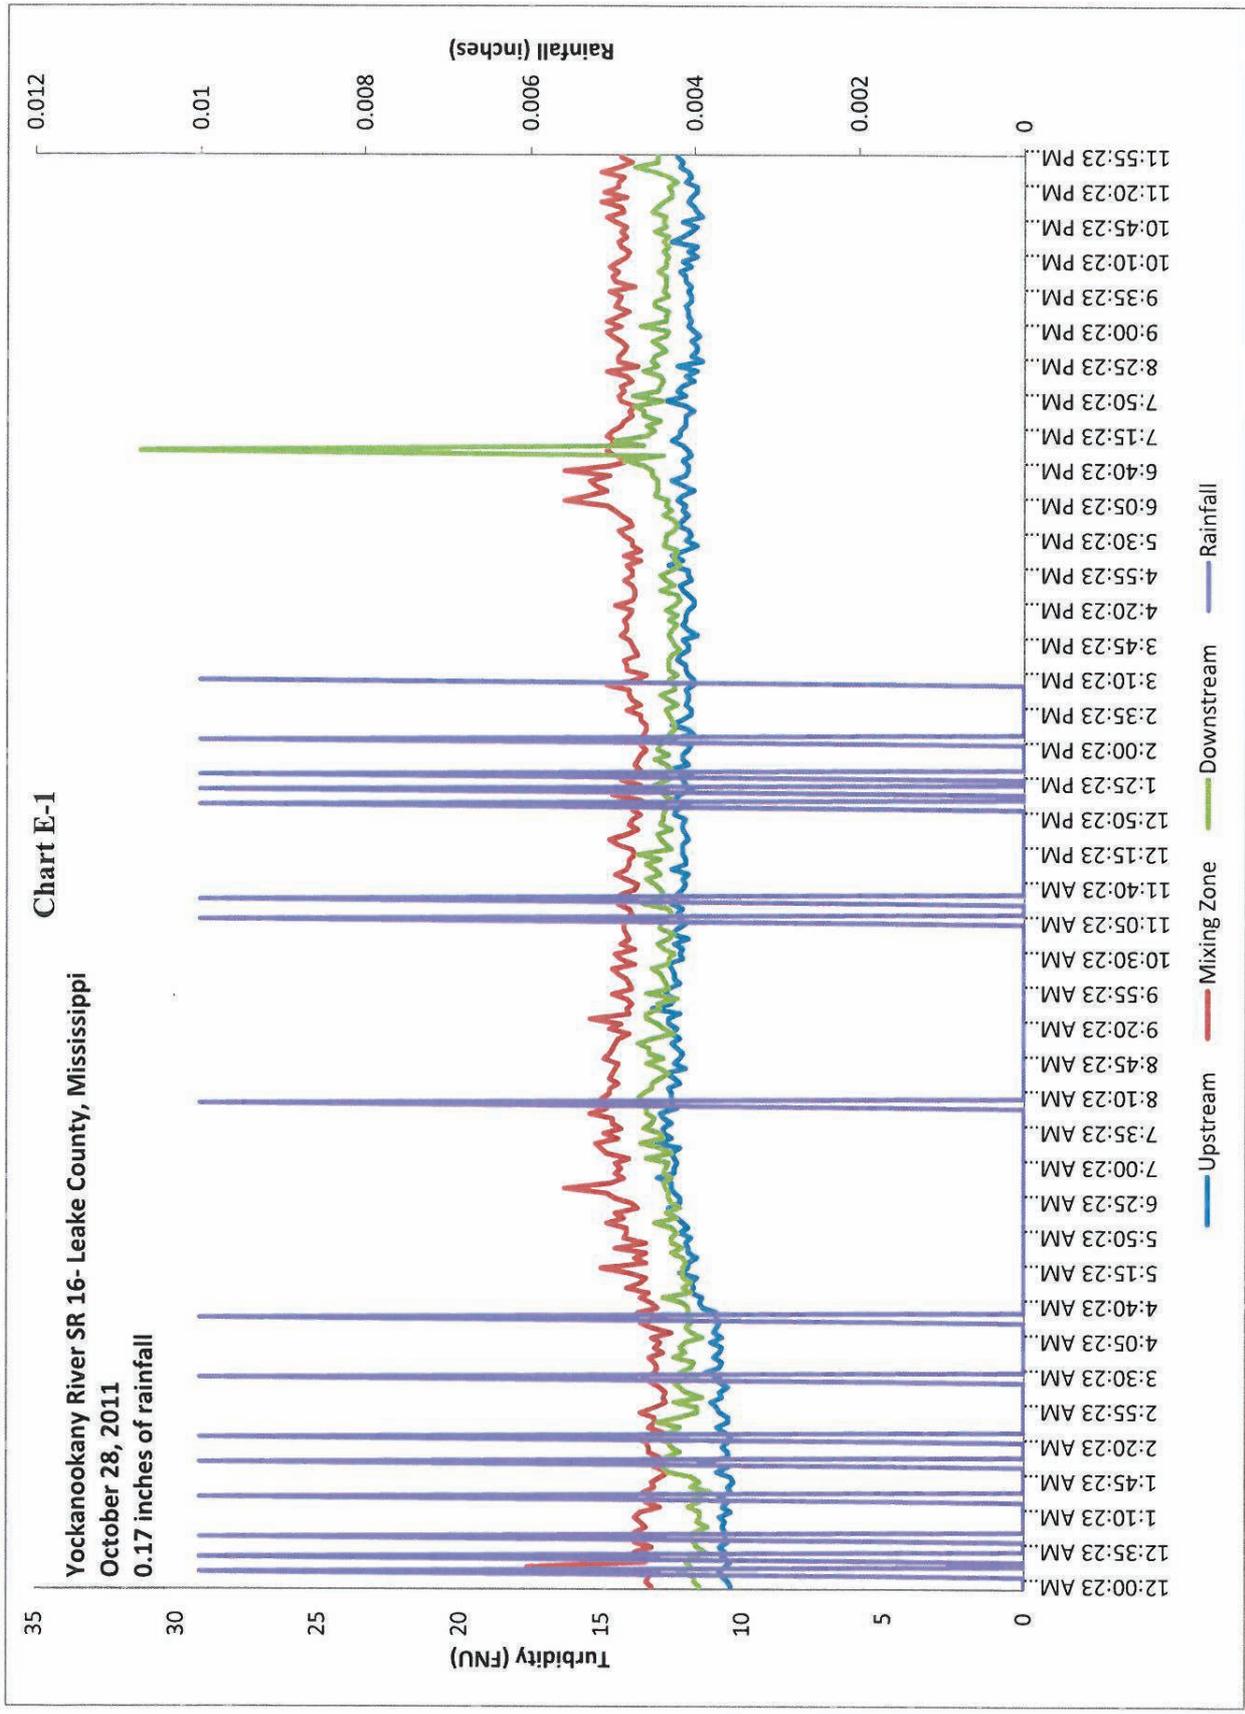
Chart E-1

Yockanookany River SR 16- Leake County, Mississippi

October 28, 2011

0.17 inches of rainfall

This site has consistently had no deficiencies related to erosion and sedimentation control BMPs since the initial inspection performed by Thompson Stormwater Inspectors on August 30, 2011. Throughout the entire monitoring period, this site stayed within the MDEQ 50 NTU regulation. On October 28, 2011 the site received 0.17 inches of rain. On November 3, 2011 the site received 0.31 inches of rain. On November 16, 2011 the site received 0.47 inches of rain. Throughout the monitoring period this site remained below the formerly EPA proposed numeric turbidity limit of 280 NTU.

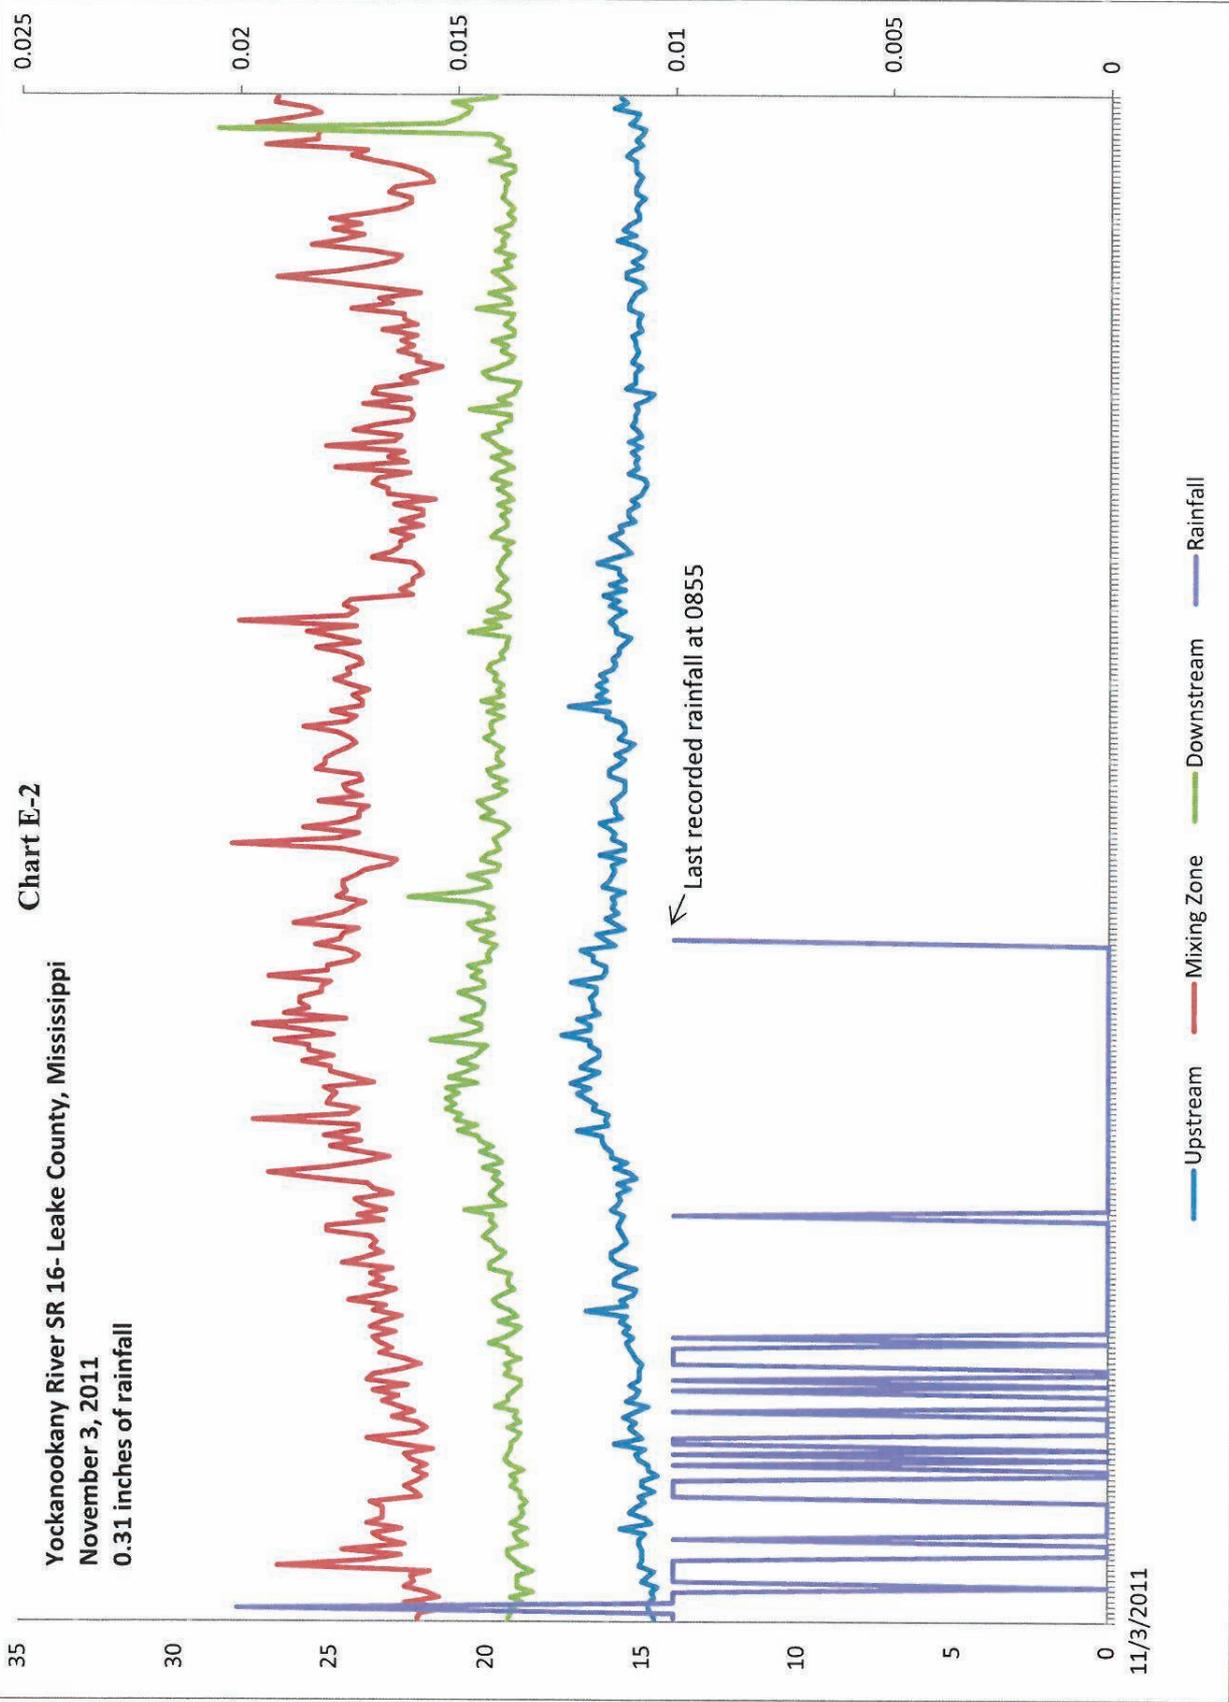
Chart E-2

Yockanookany River SR 16- Leake County, Mississippi

November 3, 2011

0.31 inches of rainfall

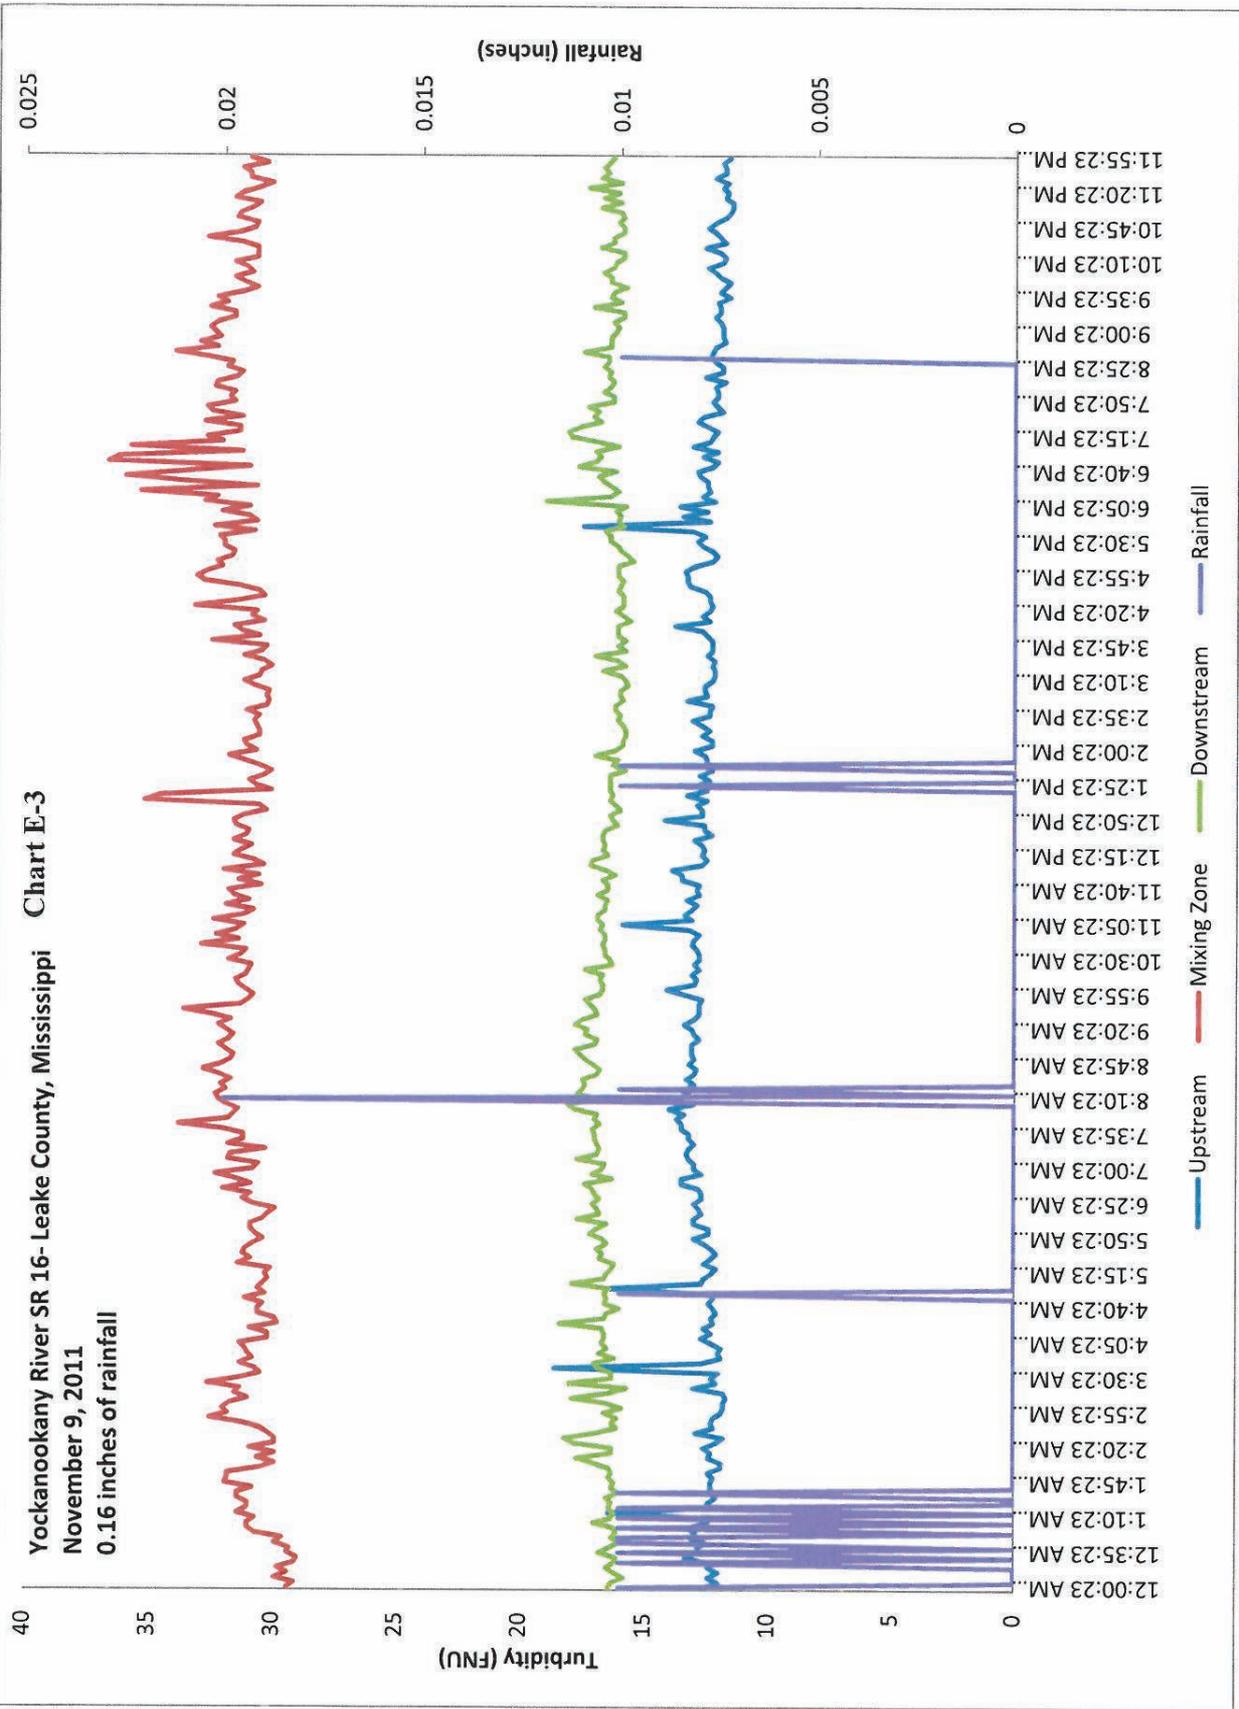
Yockanookany River SR 16- Leake County, Mississippi Chart E-3

November 9, 2011

0.16 inches of rainfall

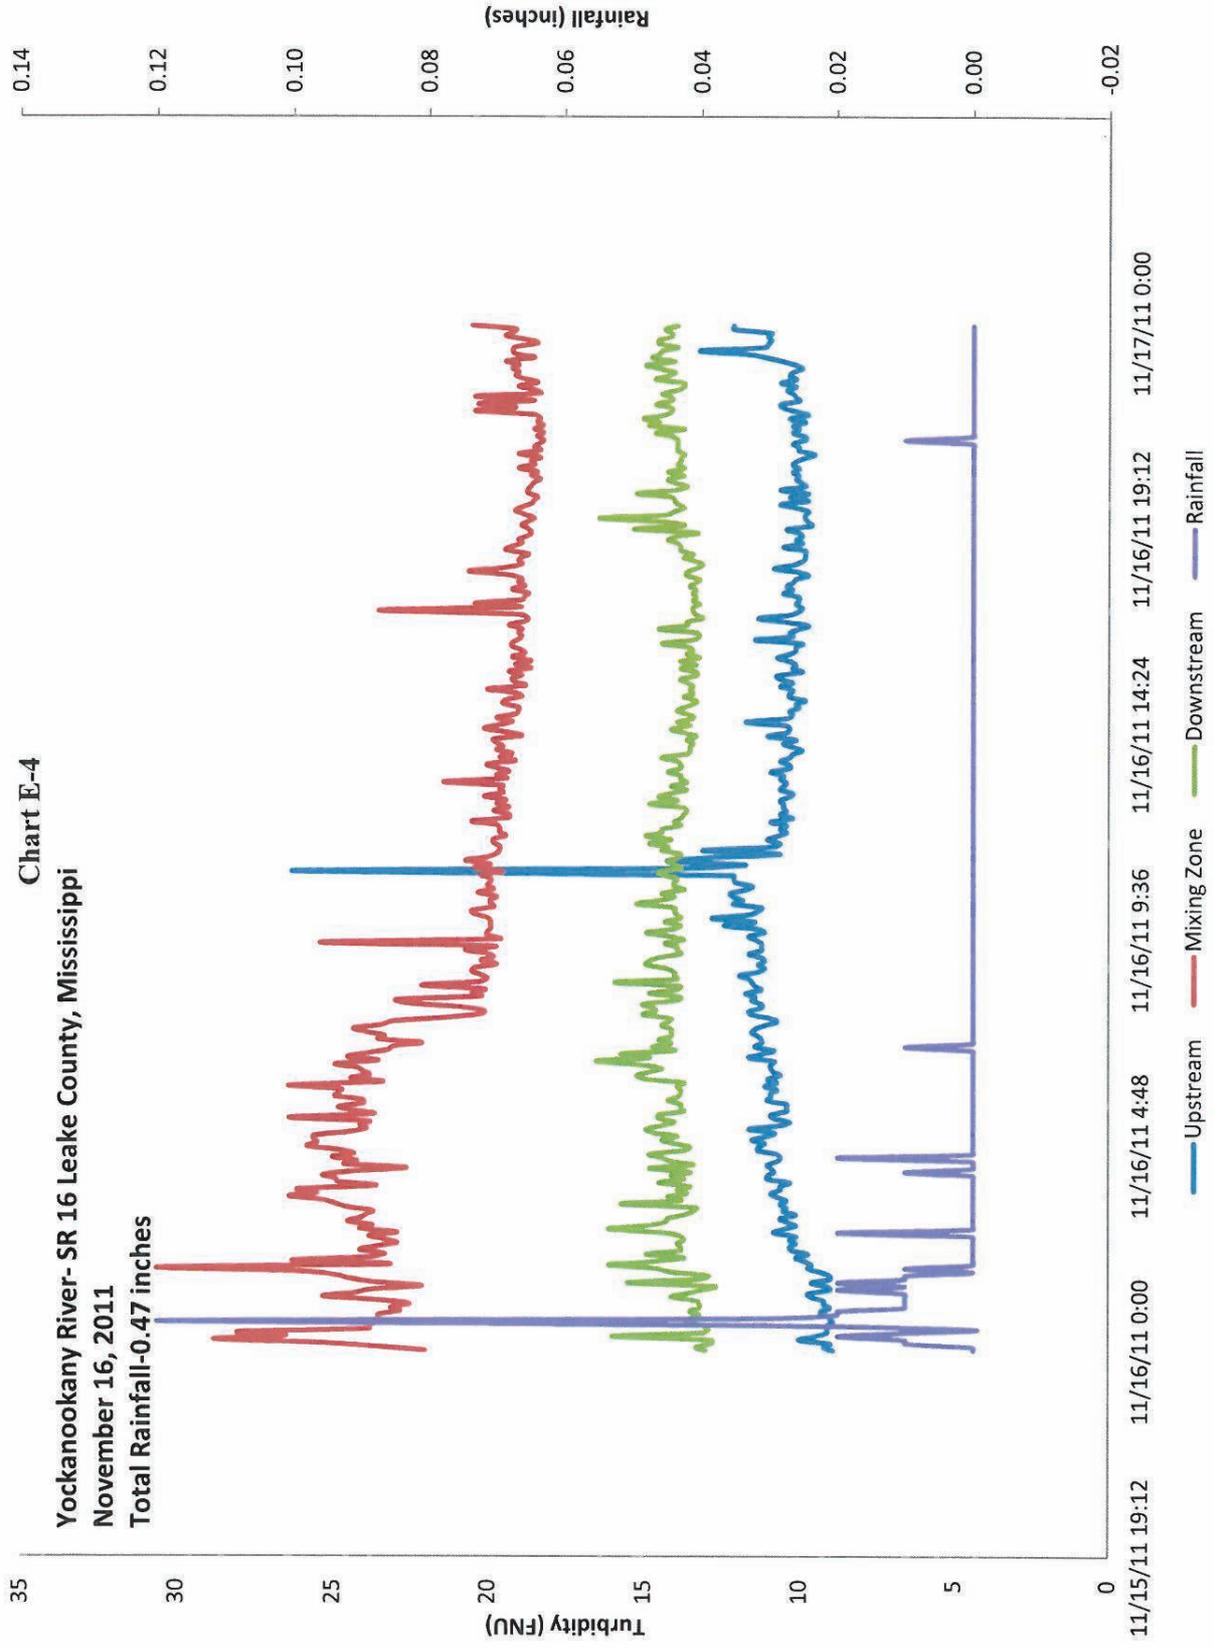
Chart E-4

Yockanookany River- SR 16 Leake County, Mississippi

November 16, 2011

Total Rainfall-0.47 inches

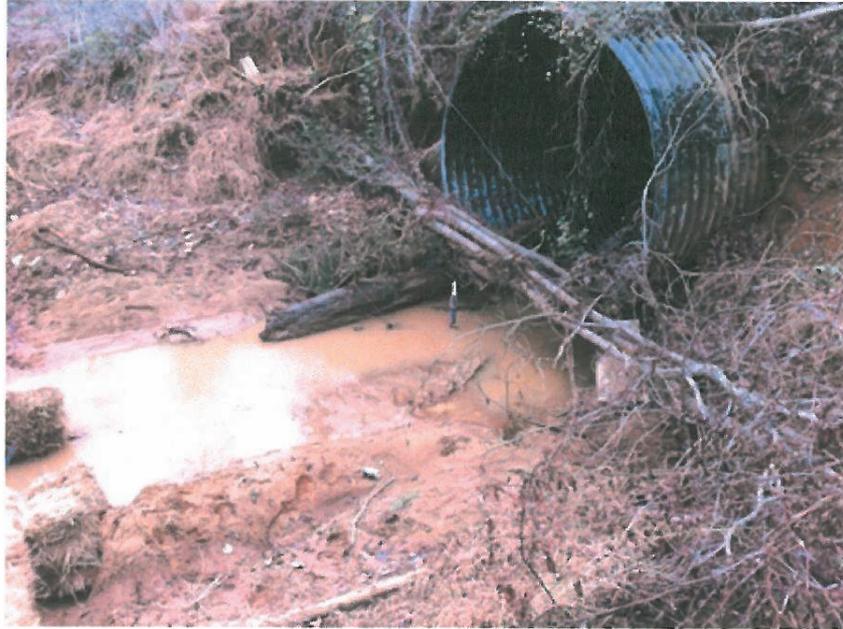
Photo F-1 Troll installed at the mixing zone sampling location

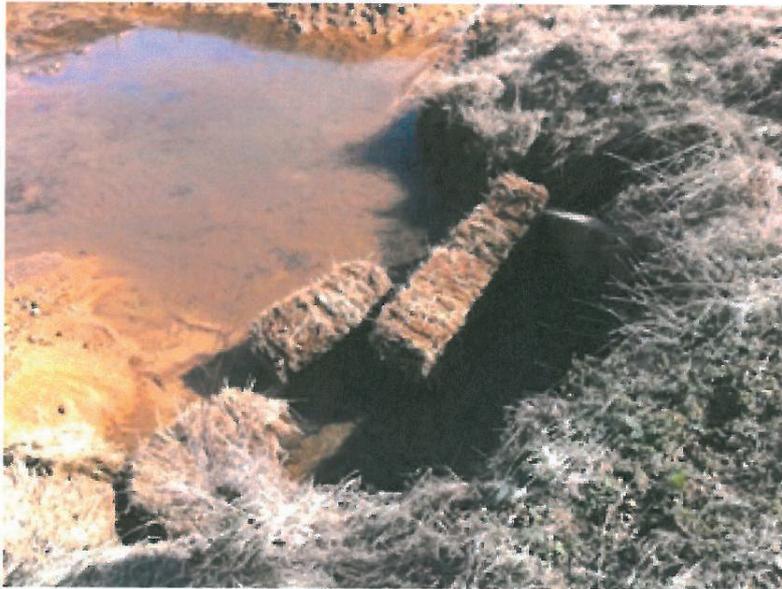
Photo F-3 Improperly placed hay bales at a drain inlet

Erosion and sedimentation control BMPs on the site included silt fence around the perimeter of the disturbed areas. The silt fence, however, was damaged or not installed properly in some areas. Hay bales were placed in areas of concentrated flow and in the stream near the culvert where stormwater entered the stream channel. Drain inlets were protected with hay bales and silt fence. Within the site there were several exposed slopes with no vegetation or mulch in place.

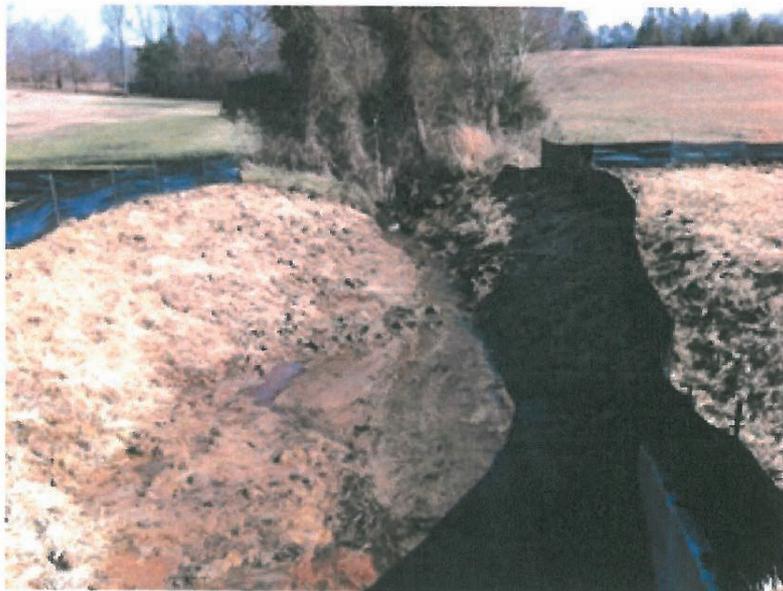
Photo F-4 Slopes mulched and silt fence installed

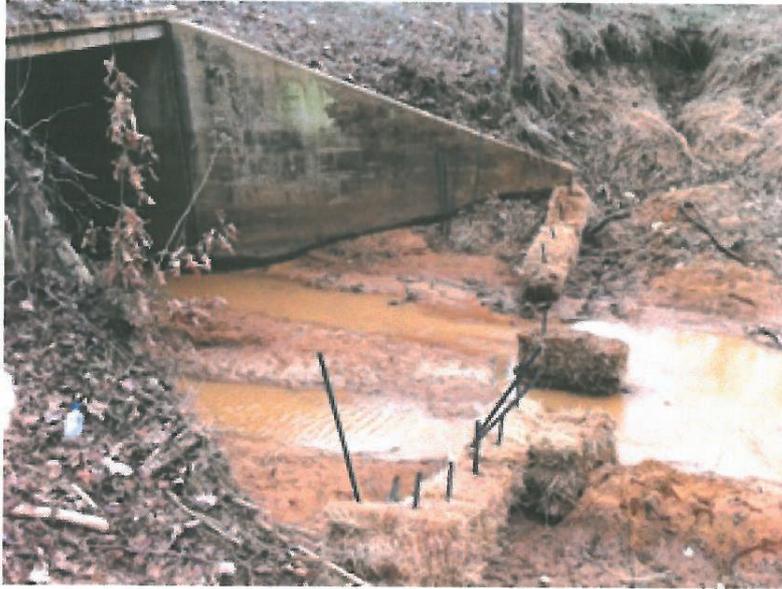
Photo F-9 Improperly installed hay bales in the stream channel

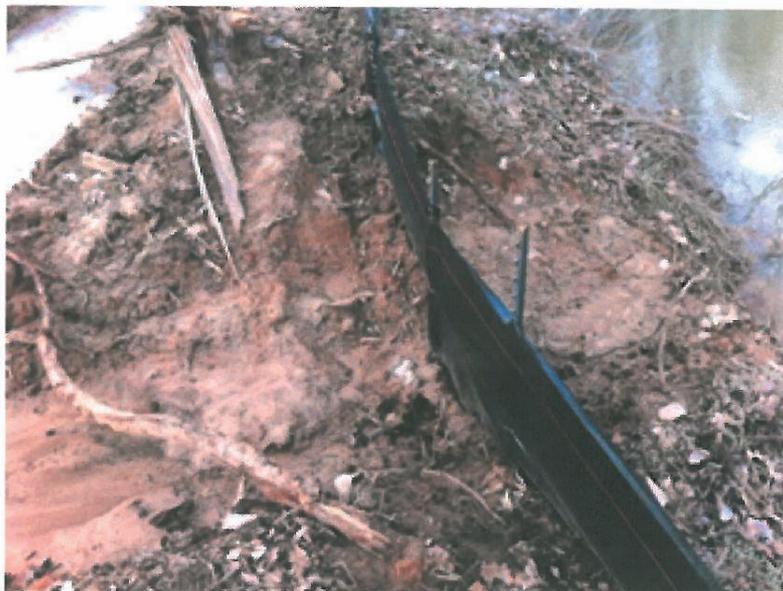
Photo F-10 Silt fence in need of maintenance

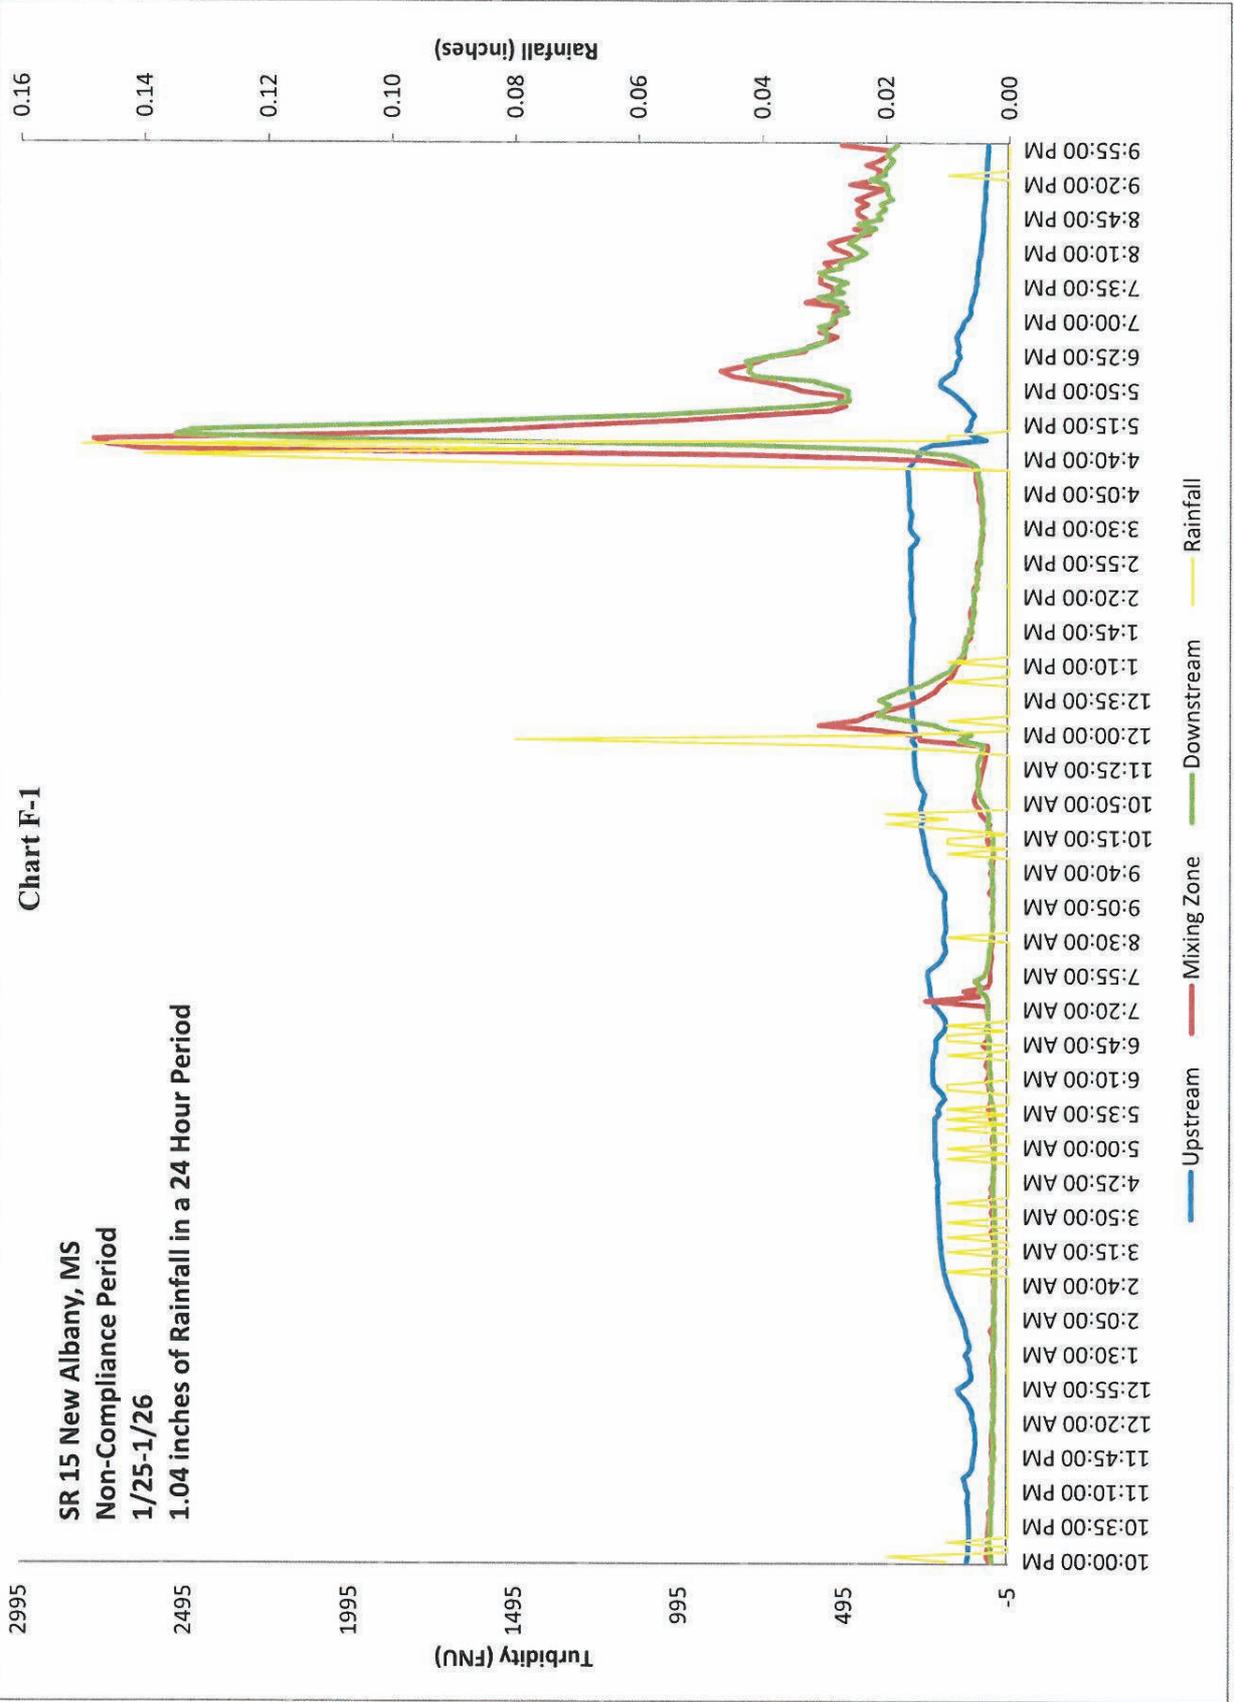
Chart F-1

SR 15 New Albany, MS
Non-Compliance Period
1/25-1/26
1.04 inches of Rainfall in a 24 Hour Period

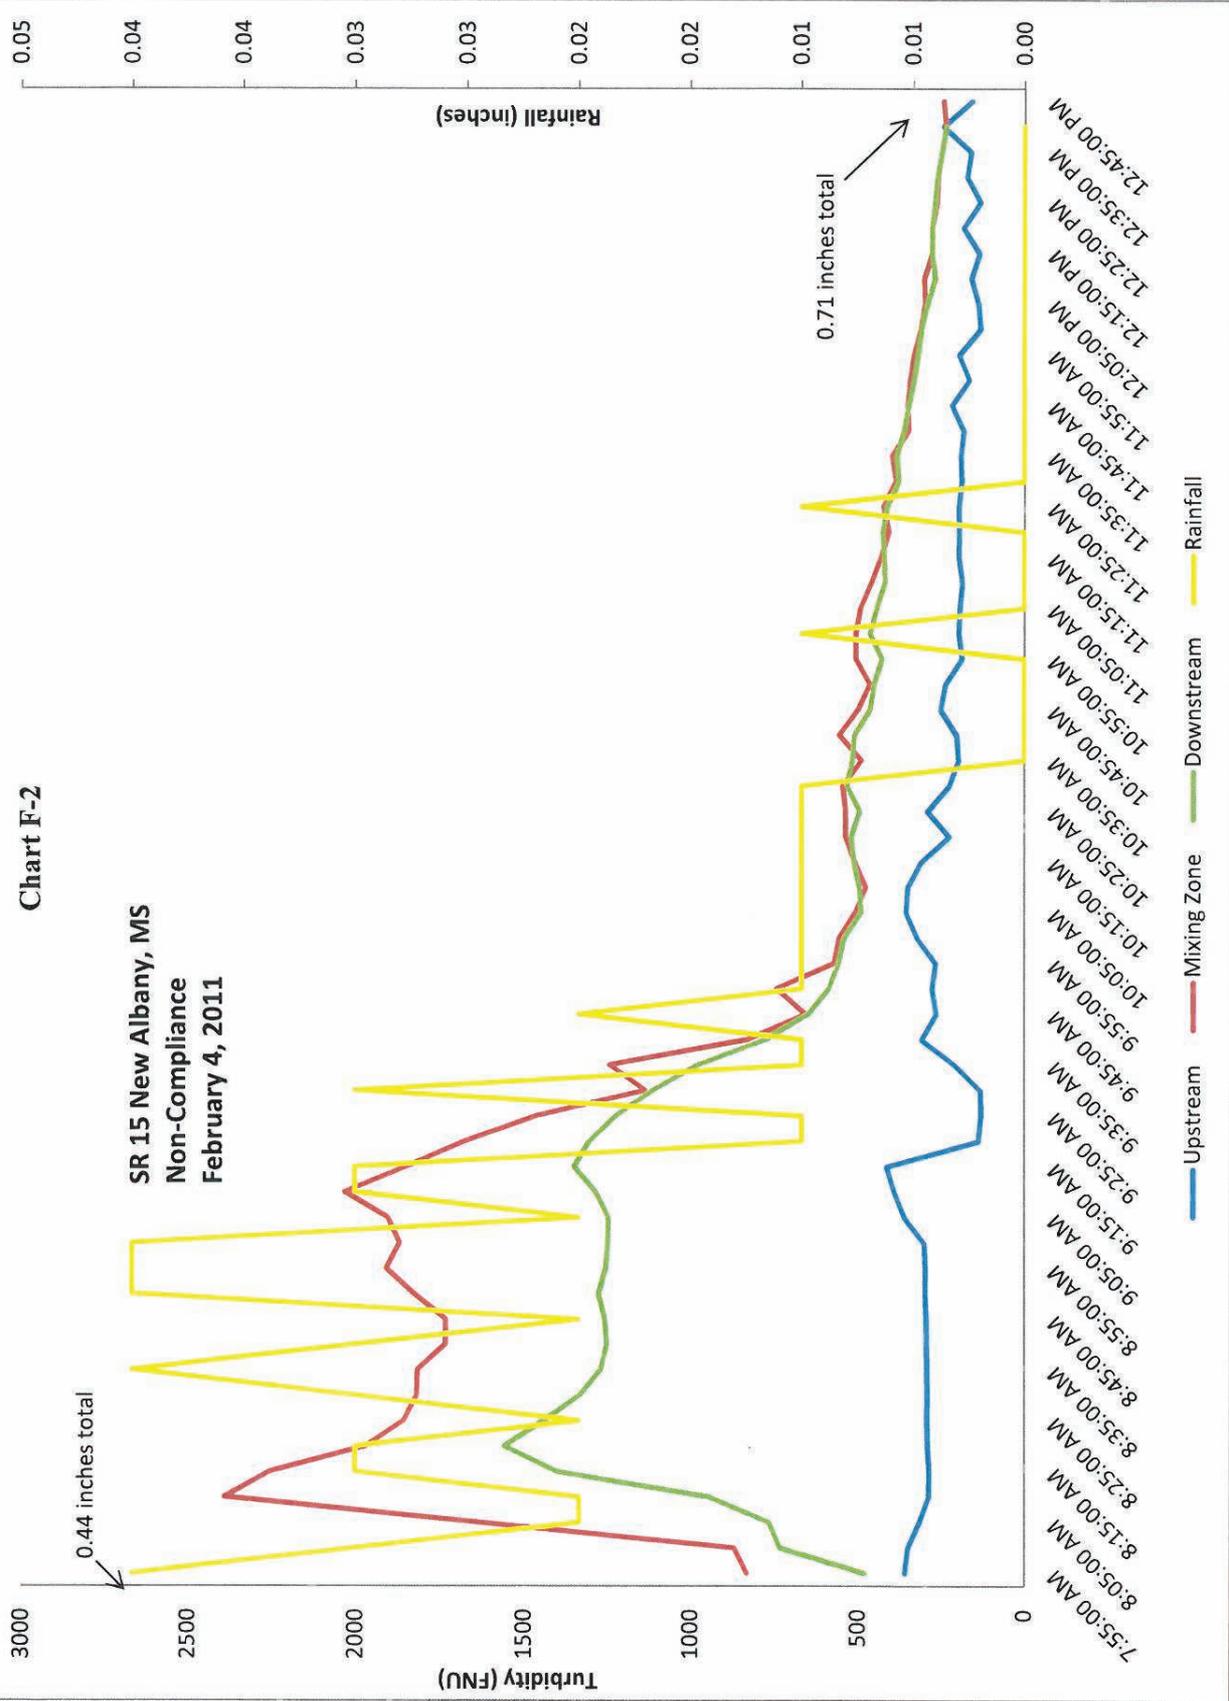
Chart F-2

SR 15 New Albany, MS
Non-Compliance
February 4, 2011

A second rainfall event was observed on February 4, 2012 February 4. The 50 NTU regulation was exceeded after 0.44 inches of rainfall in an 18.5 hour period. As was seen in the previous rain event, the increase in turbidity mimics the increase in rainfall. The downstream and mixing zone turbidity readings spike into the thousands while the upstream reading remains below 500 NTU. At the point where the downstream turbidity falls to within 50 NTU of upstream, total rainfall onsite was 0.71 inches.

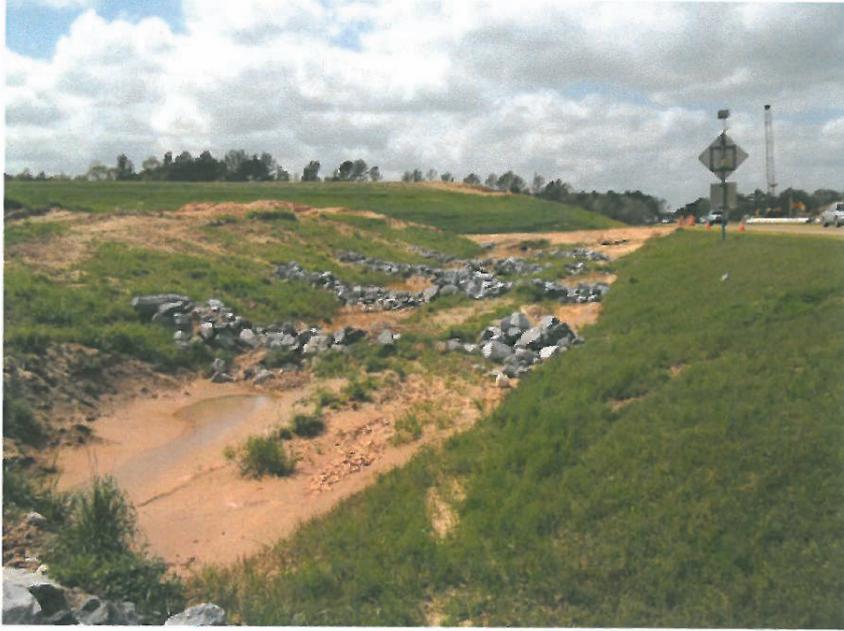
Photo G-1 Rock check dams installed in the ditch adjacent to Old Brandon Rd.

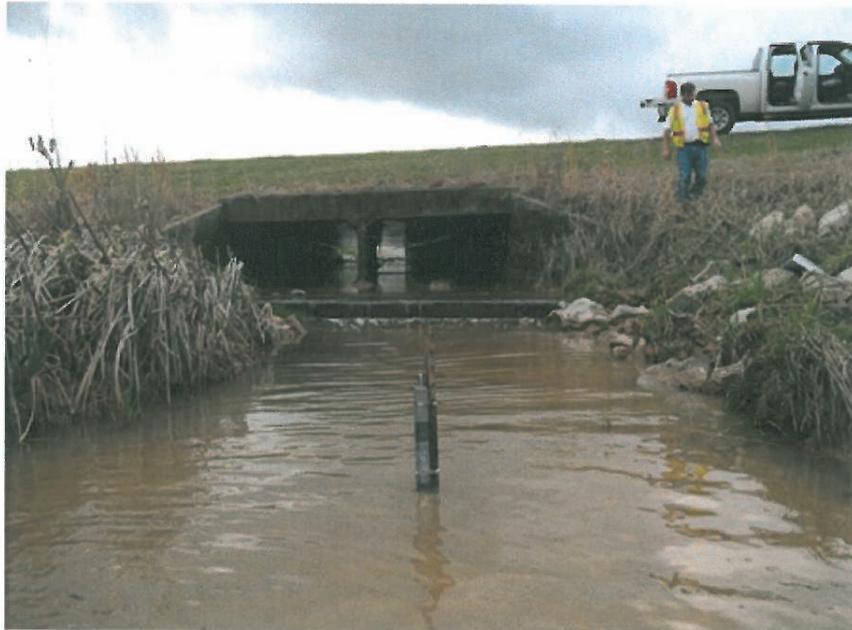
Photo G-2 Troll installed in the mixing zone sampling location

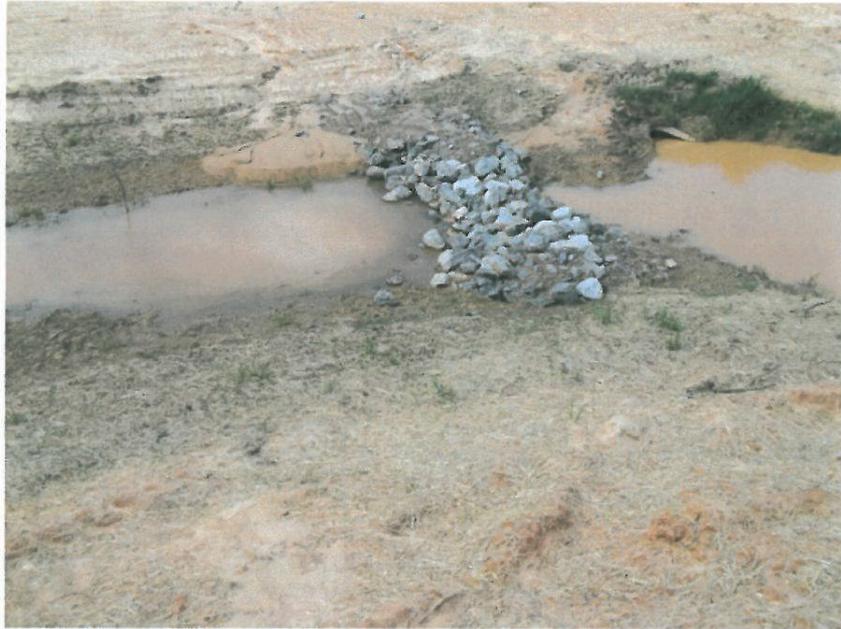
Photo G-3 Slope mulched and seeded with rock check dam installed

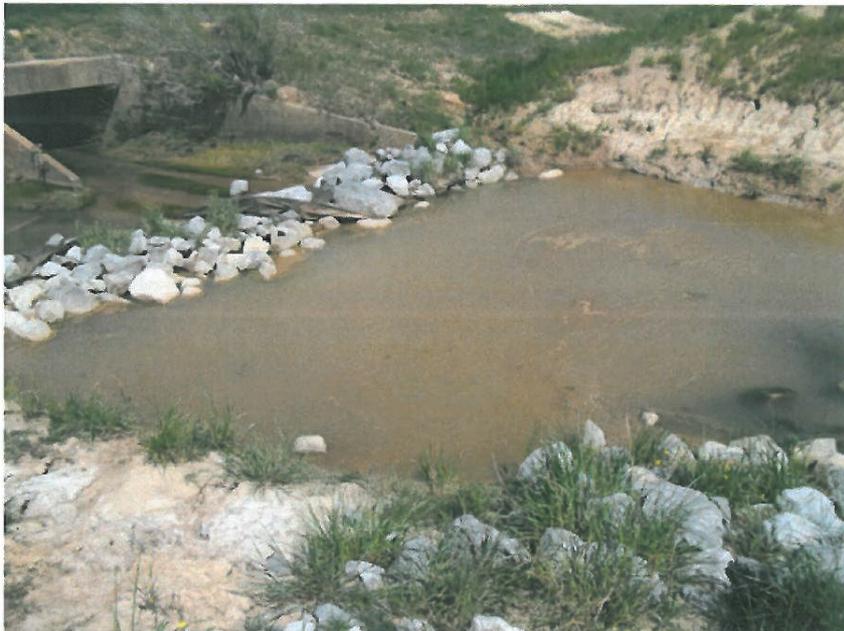
Photo G-4 Rock check dam installed near the site discharge point

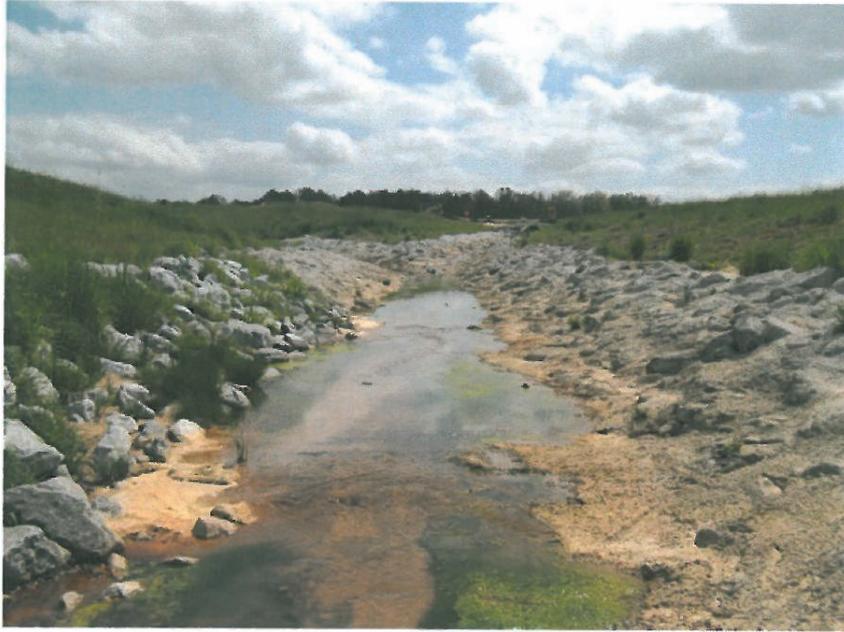
Photo G-5 Drainage ditch lined with rip rap and grouted

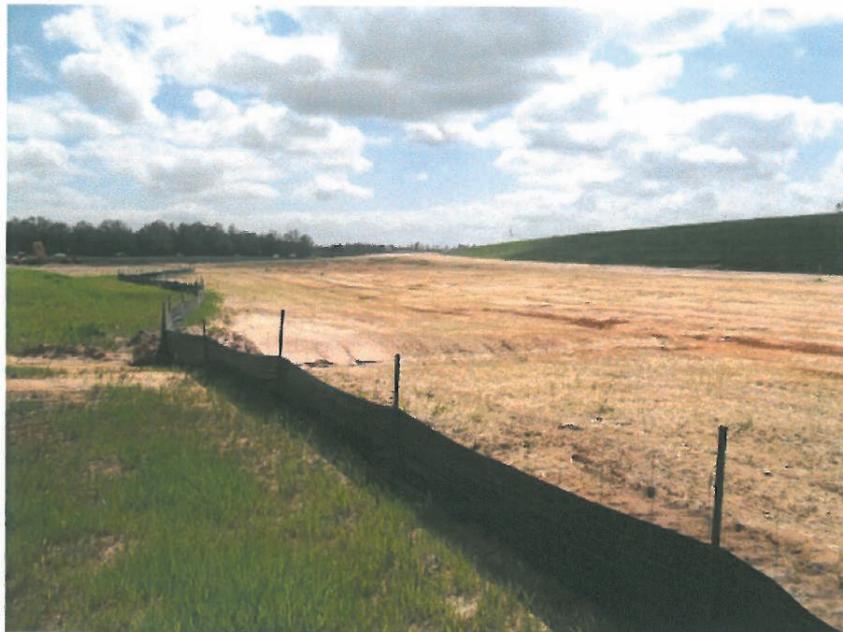
Photo G-6 Seeded and mulched with silt fence installed

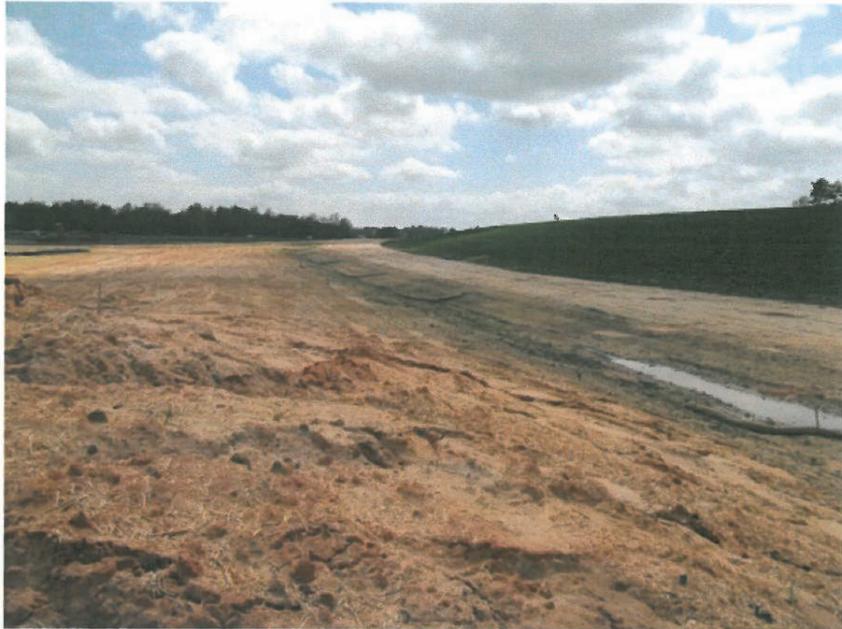
Photo G-7 Slopes either grassed or mulched with waddles installed in ditch

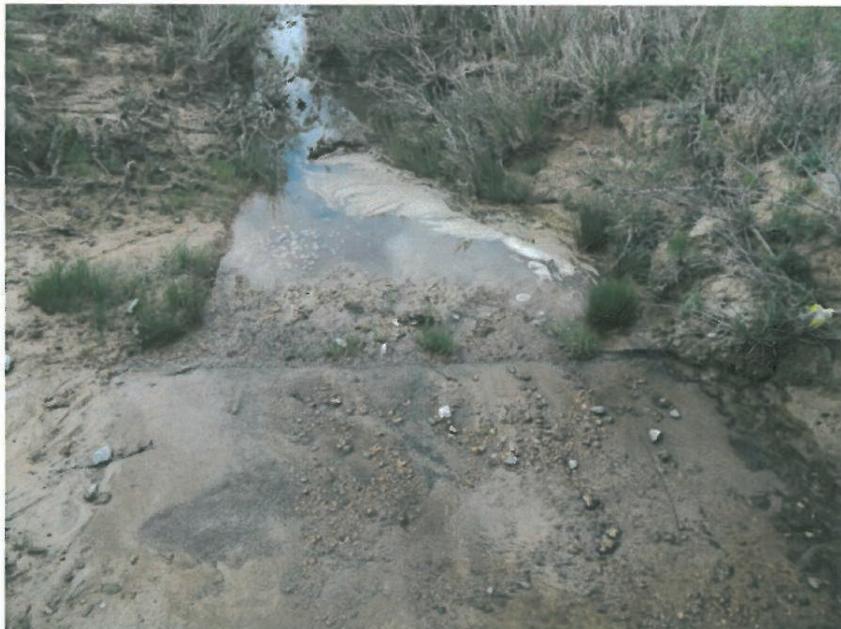
Photo G-8 Discharge point

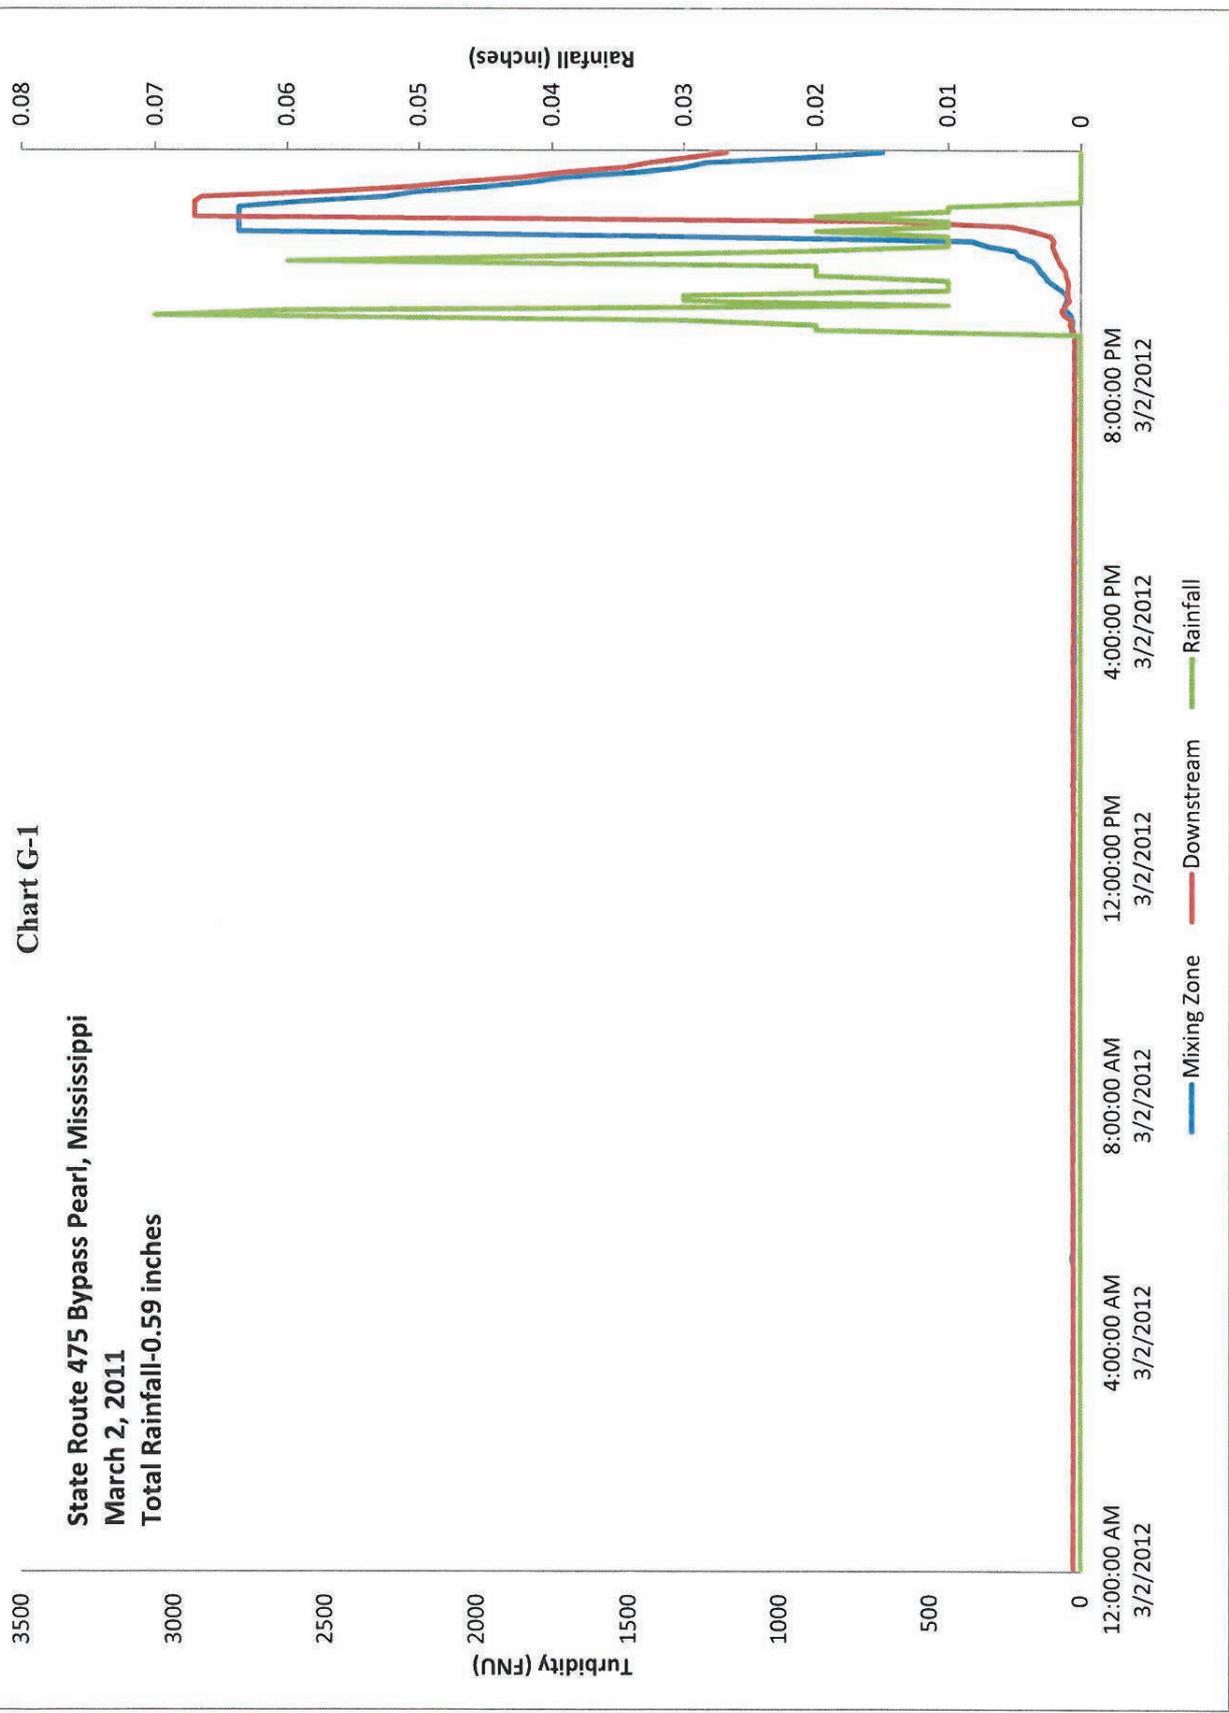
Chart G-1

State Route 475 Bypass Pearl, Mississippi
March 2, 2011
Total Rainfall-0.59 inches
